TP 185E
Issue 4/2011

AVIATION SAFETY LETTER

CFIT in Algonquin Park: a "Get-Home Itis" Case Study?

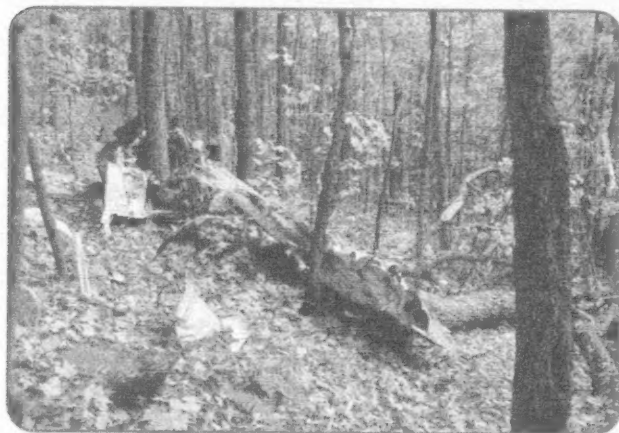
On October 10, 2009, a Piper PA-28R-180 aircraft departed Kingston, Ont., at 18:27 EDT on a night visual flight rules (VFR) flight to Sudbury, Ont. On board the aircraft were the pilot and three passengers. The estimated time of arrival at Sudbury was 20:42. At 20:52, an emergency locator transmitter (ELT) signal was reported by an overflying aircraft. The aircraft was located the following day at 03:02, approximately 22 SM east of South River, Ont. All four occupants were fatally injured.

1. The pilot, with minimal night flying experience, took off at night without fully appreciating the marginal weather that was forecast en route.
2. The pilot planned the flight over inhospitable terrain that afforded few visual cues for VFR navigation and continued flying into deteriorating weather conditions.
3. The pilot likely encountered conditions where ground reference was lost and altitude was not maintained, resulting in the aircraft striking trees in an area of rising terrain.

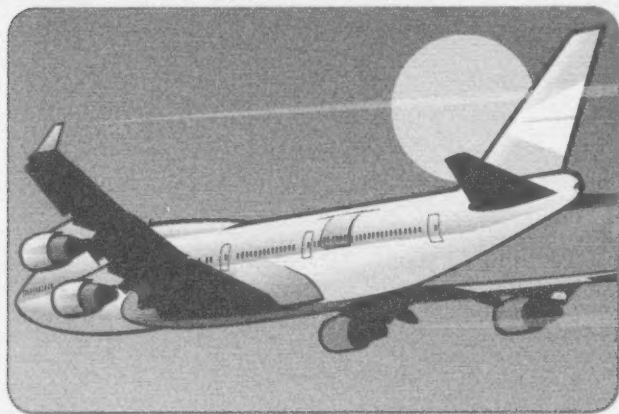
Subsequently, the door came open in flight and the flight crew had to make an emergency landing. The AMT, being a “company man” and trying to get the aircraft out on time, committed what is known as a situational violation. A situational violation occurs when an AMT, typically with good intentions, deviates from a procedure to get the job done.

A door came open in flight as a result of a desire to get the aircraft out on time.

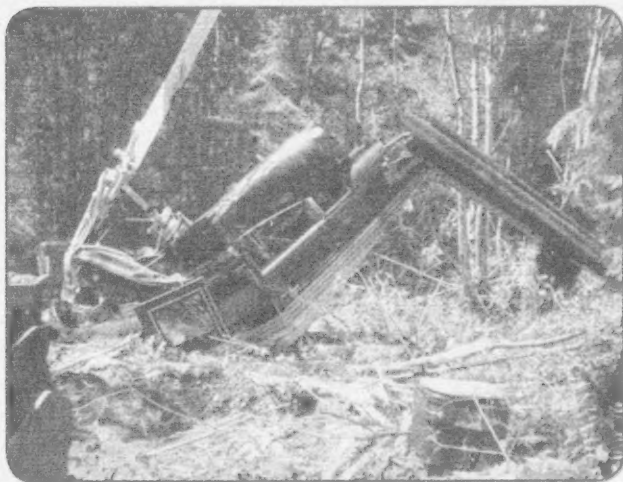
On July 2, 2007, a Bell 214B1 helicopter was carrying out heli-logging operations in Ramsay Arm, B.C. At about 08:00 PDT, the helicopter was in a 200-foot hover and starting to pick up the 11th load when the two pilots noted a loud growling sound from within the helicopter. Immediately, the flying pilot discontinued the lift and released the load from the longline hook. He then flew the helicopter back towards the nearby service area to have the noise investigated. About 20 sec later, just as the helicopter entered a high hover above the service landing site, the growling noise stopped, the low oil pressure warning lights for the two tail rotor gearboxes illuminated, and the helicopter rotated quickly to the right. The pilot was unable to stop the rotation using the tail rotor control pedals and the helicopter made two or three 360° turns to the right. The pilot rolled off the throttle on the collective stick and attempted to land in trees adjacent to the service area. The helicopter descended upright and struck several trees before landing hard on the uneven terrain. The flying pilot, seated in the left hand seat, was seriously injured and the co-pilot received minor injuries. The helicopter was substantially damaged during the landing and there was no fire. The emergency locator transmitter activated at impact and survived the crash.

Bell 214B1 wreckage

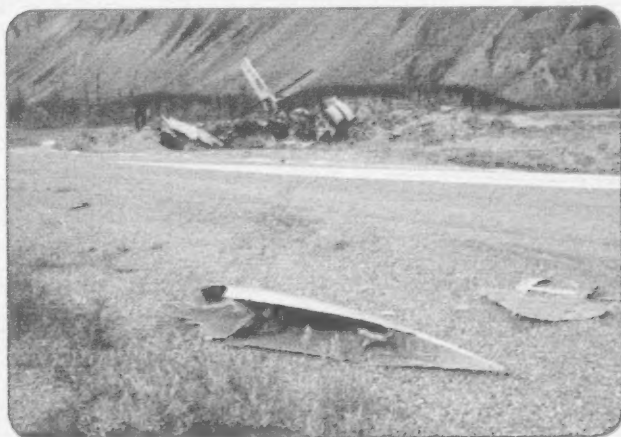
On July 8, 2007, at approximately 12:35 PDT, a de Havilland DHC-6-100 Twin Otter was taking off from a gravel airstrip near the Northern Rockies Lodge at Muncho Lake on a visual flight rules flight to Prince George, B.C. After becoming airborne, the aircraft entered a right turn and the right outboard flap hanger contacted the Alaska Highway. The aircraft subsequently struck a telephone pole and a telephone cable, impacted the edge of the highway a second time, and crashed onto a rocky embankment adjacent to a dry creek channel. The aircraft came to rest upright approximately 600 ft from the departure end of the airstrip. An intense post-impact fire ensued and the aircraft was destroyed. One passenger suffered fatal burn injuries, one pilot was seriously burned, the other pilot sustained serious impact injuries, and the other two passengers received minor injuries.

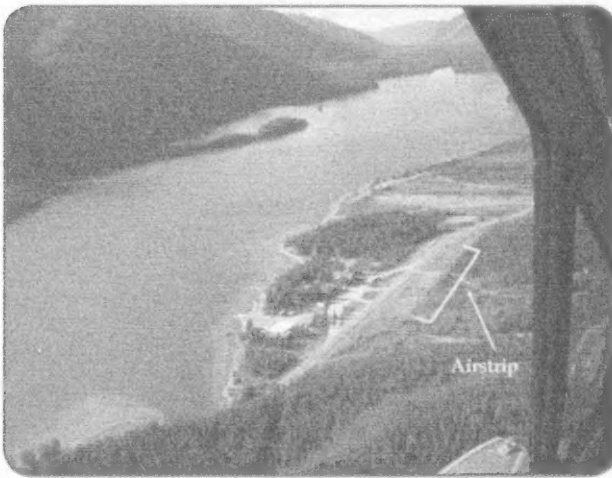
Despite regular use of the lodge airstrip and recognition by the owner that take-off weights were a critical consideration in these operations, there was no standard operating procedure (SOP) for Twin Otter short-field operations. An applicable SOP would have formalized and set the non-MPS limits for short field operations, thereby reducing the risk associated with lodge airstrip operations.

Lodge airstrip in direction of takeoff

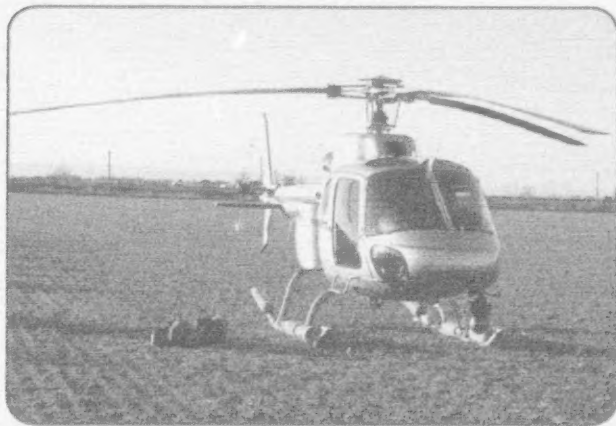
Turbomeca Arriel 2B) had failed and the pilot commenced an autorotation landing into a farm field. During the descent, the pilot transmitted a mayday call and activated the emergency locator transmitter. The helicopter landed without further incident. There were no injuries and the helicopter was not damaged. The pilot completed the shutdown checklist and switched off the battery.

AS 350 sitting in the field after the successful autorotation with no damage at all. Great job by the pilot!

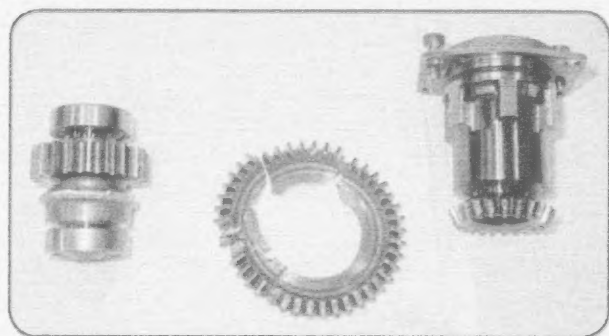
An examination of the engine determined that the 41-tooth bevel gear (part number 0292127330) had fractured due to high-cycle fatigue cracking. The gear was installed during engine manufacture and had accumulated a total of 1 644 hr since new. Metallurgical examination (TSB Laboratory report LP 005/2008) of the bevel gear revealed numerous fatigue cracks radiating from the roots of many of the gear teeth. Circumferential fatigue cracks were also observed in the rim of the gear. There were no relevant manufacturing flaws found in the gear that could contribute to the failure.

Fractured 41-tooth bevel gear shown with other parts from the accessory gearbox

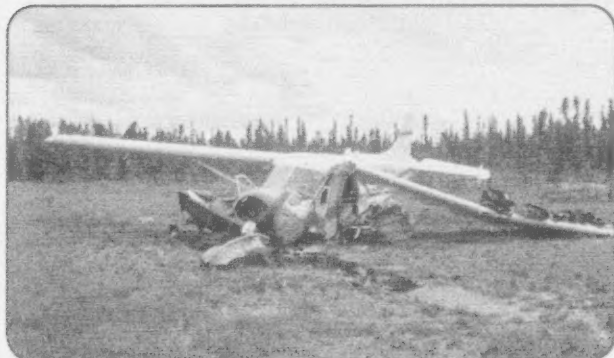
crashed in a bog. The pilot and four of the occupants were seriously injured; two occupants received minor injuries. The aircraft was substantially damaged, but there was no post-impact fire. The impact forces activated the onboard emergency locator transmitter.

The damaged aircraft after the accident

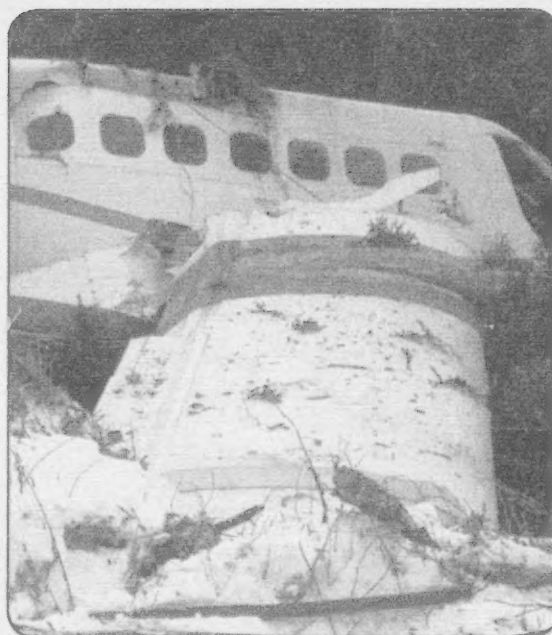
On February 4, 2009, a ski-equipped de Havilland DHC-6 Series 100 was taking off from a ski strip east of and parallel to Runway 36 at La Ronge, Sask. After the nose ski cleared the snow, the left wing rose and the aircraft veered to the right and the captain, who was the pilot flying, continued the takeoff. However, the right ski was still in contact with the snow. The aircraft became airborne briefly as it cleared a deep gully to the right of the runway. The aircraft remained in a steep right bank and the right wing contacted the snow-covered ground. The aircraft flew through a chain link fence and, at approximately 09:15 CST, crashed into trees surrounding the airport. The five passengers and two crew members evacuated the aircraft with minor injuries. There was a small fire near the right engine exhaust that was immediately extinguished by the crew.

1. Contamination on the wings of the aircraft was not fully removed before takeoff. It is likely that asymmetric contamination of the wings created a lift differential and a loss of lateral control.
2. Although the operator was not authorized for short takeoff and landing (STOL) takeoff on this aircraft, the crew conducted a STOL takeoff, which reduced the aircraft's safety margin relative to its stalling speed and minimum control speed.
3. As a result of the loss of lateral control, the slow STOL take-off speed, and the manipulation of the flaps, the aircraft did not remain airborne and veered right, colliding with obstacles beside the ski strip.

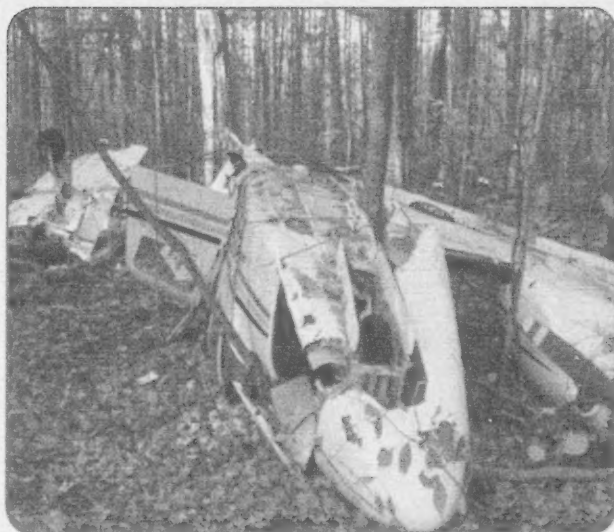
1. The right fuel selector was left in the XFEED position, probably because the pilot was distracted and/or failed to follow the checklist. As a result, both engines were being fuelled by the left tank until it was completely empty, causing both engines to stop simultaneously.
2. The pilot relied on a fuel quantity indicator system that was based on the engine's fuel consumption and not on the quantity of fuel remaining indicated by the gauges.
3. The pilot did not recognize the power loss as being a failure of both engines. The emergency checklist for engine failure was not completed.

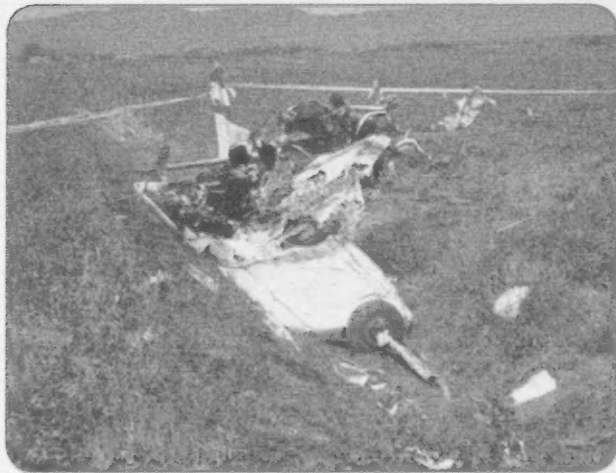
The accident occurred because the aircraft, while flying just above the ground, struck a mound 8 ft in height. Due to a lack of evidence, the investigation was unable to determine why the pilot stopped the climb after the touch-and-go landing and continued flying at low altitude. Nor could it be determined why the aircraft descended to a few feet above terrain, which was unsuitable for landing, just before the initial impact.
